SMOKE TESTING OBSERVATION SUMMARY

Western Run Pilot Project - Baltimore Maryland

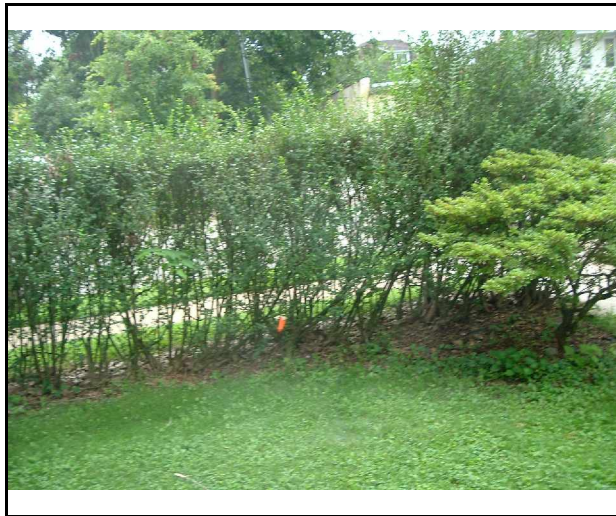
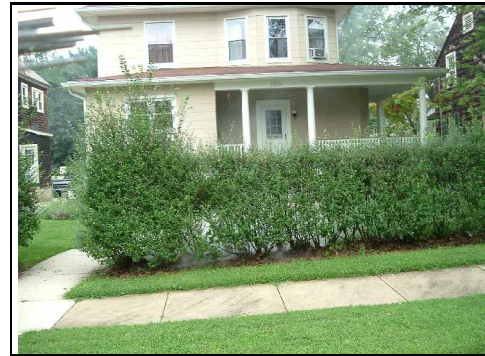
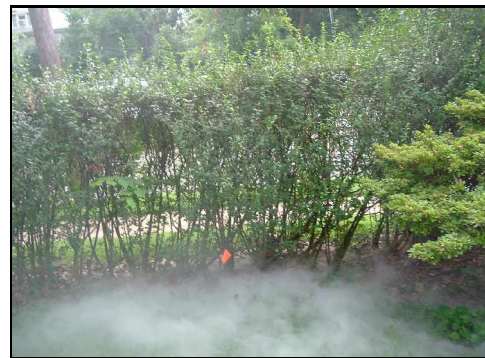
Photo No: 4

Unique Test ID	35	Date:	8/19/2004	MeterBasin:	01_WR18
Observer ID:	B	Crew:	T-1	Dye Test Recommended:	N
Defect No:	1	Setup No:	3	Priority CCTV:

House Number	Street Prefix:	Street Name:	Street Type:
2604		Ken Oak	ROAD

Source Type:	02= Service Line	Location:	7=Yard-Front	Severity:
Sector:	2=Private	Drainage Area:	75

Comments: holes in ground

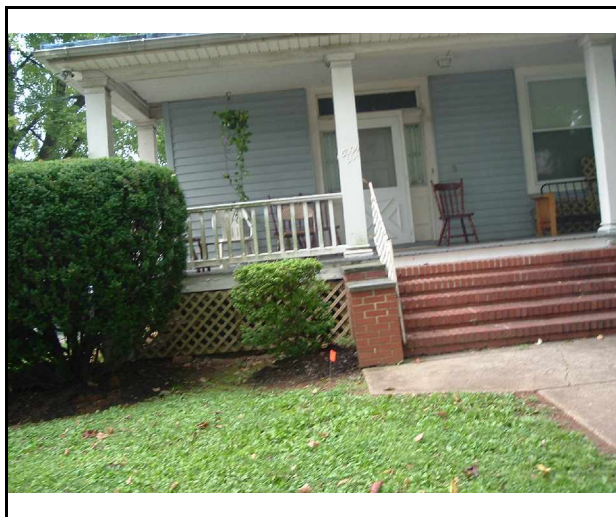
Photo No: 7

Unique Test ID	35	Date:	8/19/2004	MeterBasin:	01_WR18
Observer ID:	B	Crew:	T-1	Dye Test Recommended:	N
Defect No:	2	Setup No:	3	Priority CCTV:

House Number	Street Prefix:	Street Name:	Street Type:
5504		Stuart	AVE

Source Type:	02= Service Line	Location:	7=Yard-Front	Severity:
Sector:	2=Private	Drainage Area:	75

Comments: holes in ground

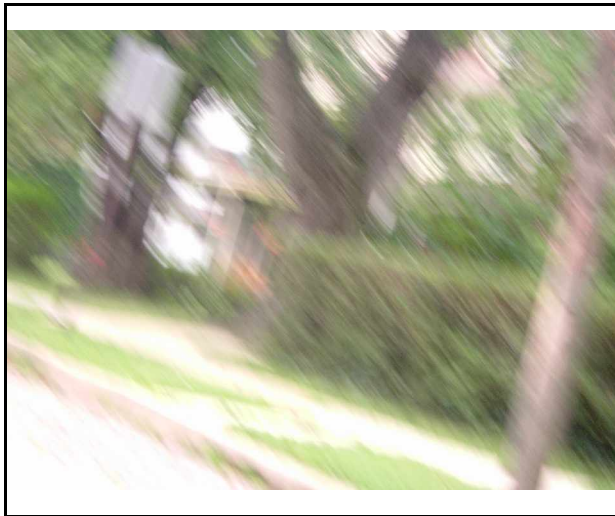
Photo No: 8

Unique Test ID	35	Date:	8/19/2004	MeterBasin:	01_WR18
Observer ID:	B	Crew:	T-1	Dye Test Recommended:	N
Defect No:	3	Setup No:	3	Priority CCTV:

House Number	Street Prefix:	Street Name:	Street Type:
2600		Ken Oak	ROAD

Source Type:	18= Other	Location:	7=Yard-Front	Severity:
Sector:	1=Public	Drainage Area:	25	
Comments:	holes in ground

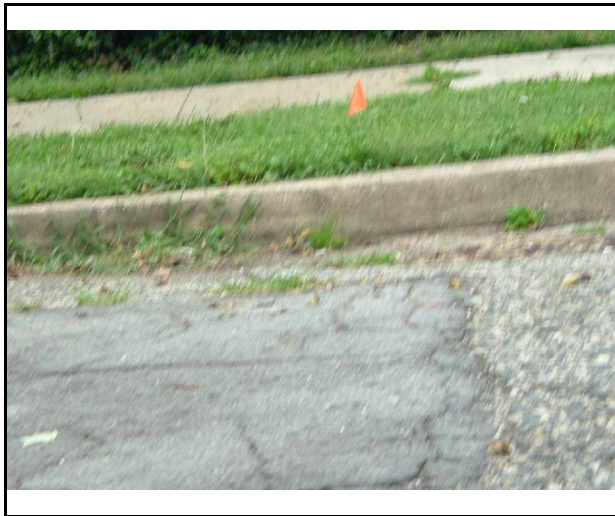
Photo No: 9

Unique Test ID	35	Date:	8/19/2004	MeterBasin:	01_WR18
Observer ID:	B	Crew:	T-1	Dye Test Recommended:	N
Defect No:	4	Setup No:	3	Priority CCTV:

House Number	Street Prefix:	Street Name:	Street Type:	
2600		Ken Oak	ROAD	
Source Type:	01= Main Sewer	Location:	2=Paved Asphalt	Severity:
Sector:	1=Public	Drainage Area:	0	
Comments:	manhole

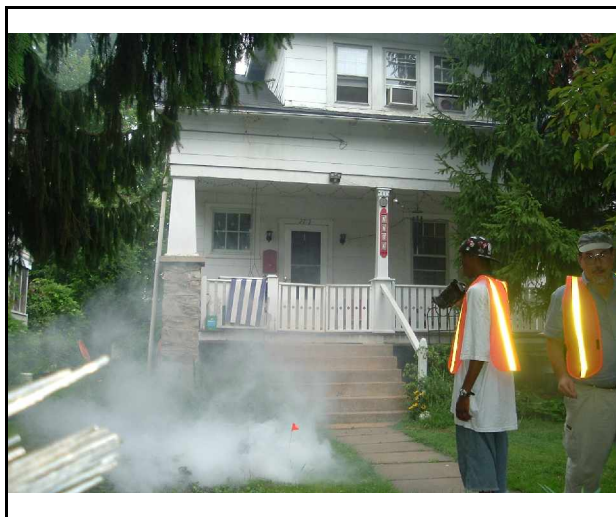
Photo No: 7

Unique Test ID	36	Date:	8/19/2004	MeterBasin:	01_WR19
Observer ID:	A	Crew:	T-1	Dye Test Recommended:	N
Defect No:	1	Setup No:	4	Priority CCTV:

House Number	Street Prefix:	Street Name:	Street Type:
2712		Manhattan	AVE

Source Type:	04= Cleanout	Location:	7=Yard-Front	Severity:
Sector:	2=Private	Drainage Area:	50

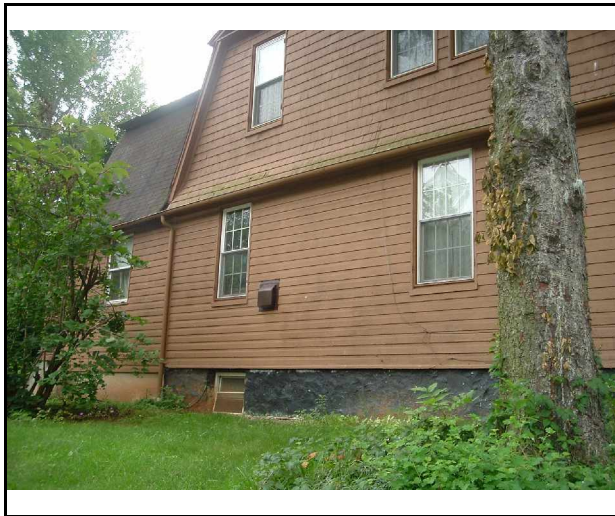
Photo No: 8

Unique Test ID	36	Date:	8/19/2004	MeterBasin:	01_WR19
Observer ID:	A	Crew:	T-1	Dye Test Recommended:	N
Defect No:	2	Setup No:	4	Priority CCTV:

House Number	5609	Street Prefix:		Street Name:	Merville	Street Type:	AVE
Source Type:	18= Other	Location:	14=Other	Severity:			
Sector:	2=Private	Drainage Area:	0				
Comments:	Plumbing vent

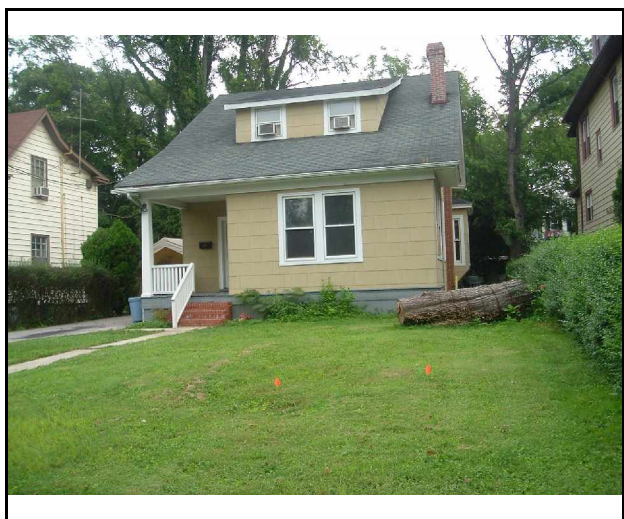
Photo No: 9

Unique Test ID	36	Date:	8/19/2004	MeterBasin:	01_WR19
Observer ID:	A	Crew:	T-1	Dye Test Recommended:	N
Defect No:	3	Setup No:	4	Priority CCTV:

House Number	Street Prefix:	Street Name:	Street Type:
5605		Merville	AVE

Source Type:	02= Service Line	Location:	7=Yard-Front	Severity:
Sector:	2=Private	Drainage Area:	50

Comments: hole grd.

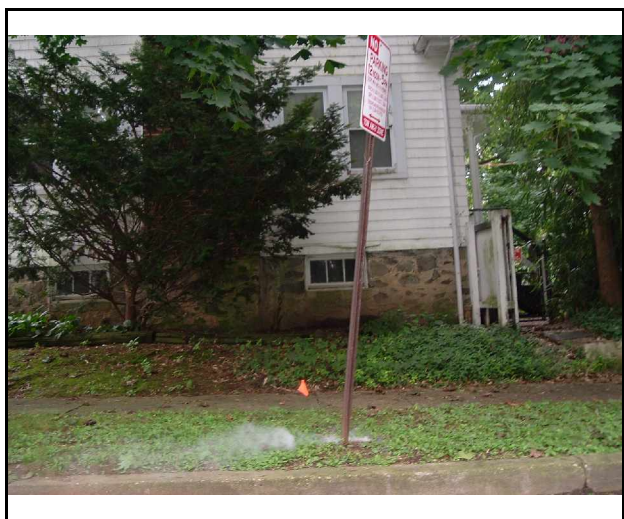
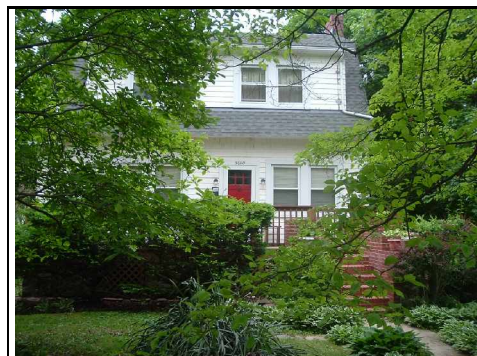
Photo No: 10

Unique Test ID	36	Date:	8/19/2004	MeterBasin:	01_WR19
Observer ID:	B	Crew:	T-1	Dye Test Recommended:	N
Defect No:	1	Setup No:	4	Priority CCTV:

House Number	Street Prefix:	Street Name:	Street Type:
5610		Merville	AVE

Source Type:	02= Service Line	Location:	9=Yard-Side	Severity:
Sector:	2=Private	Drainage Area:	50

Comments: hole in ground between curb and sidewalk

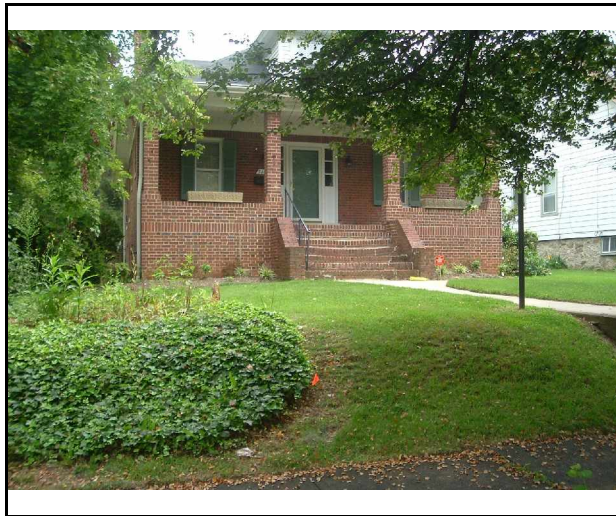
Photo No: 10

Unique Test ID	37	Date:	8/19/2004	MeterBasin:	01_WR19
Observer ID:	A	Crew:	T-1	Dye Test Recommended:	N
Defect No:	1	Setup No:	5	Priority CCTV:

House Number	5609	Street Prefix:		Street Name:	Woodcrest	Street Type:	AVE
Source Type:	04= Cleanout	Location:	7=Yard-Front	Severity:			
Sector:	2=Private	Drainage Area:	25				
Comments:

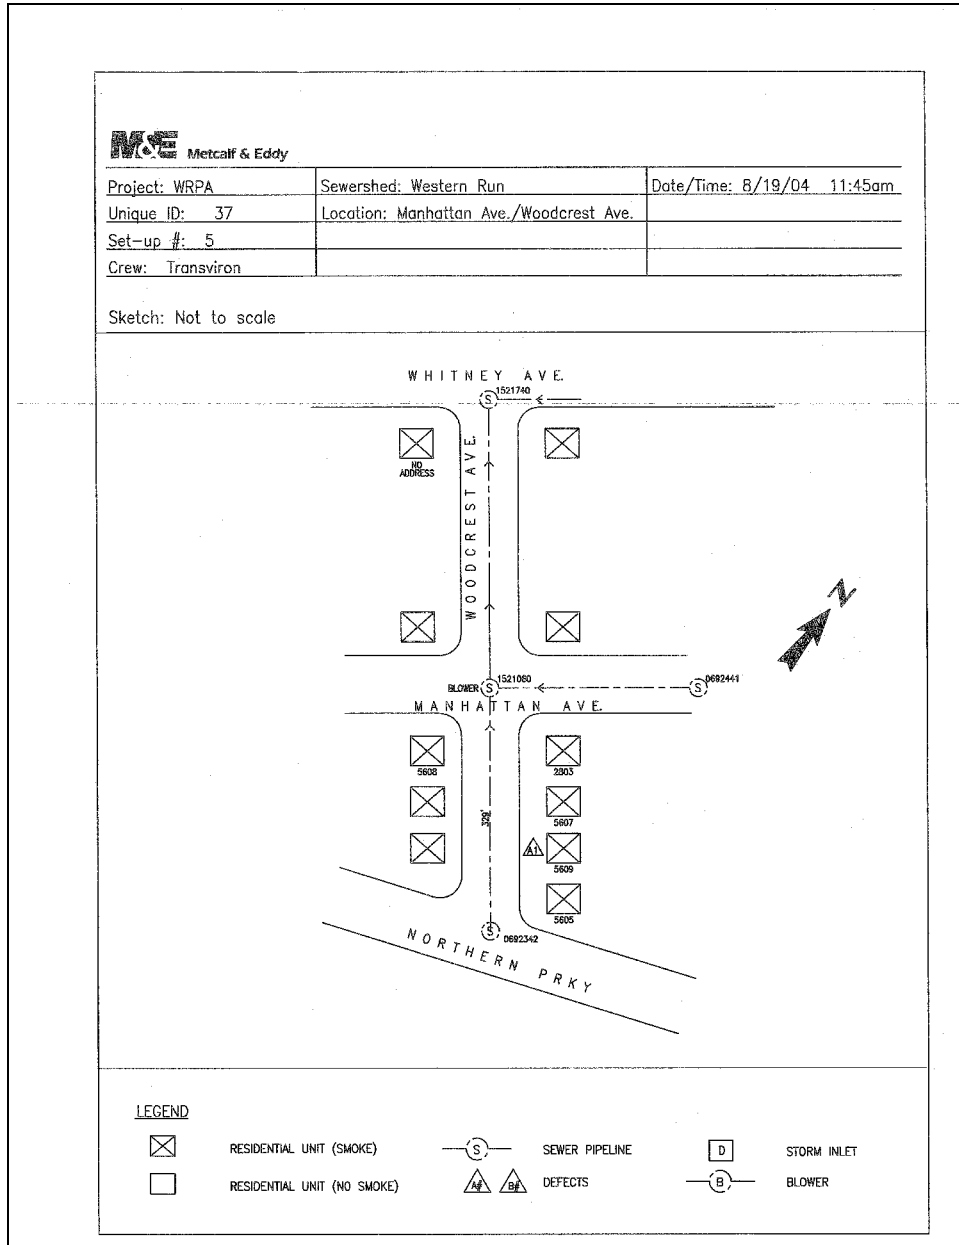
Unique Test ID	37	Date:	8/19/2004	MeterBasin:	
Observer ID:	B	Crew:	T-1	Dye Test Recommended:	N
Defect No:	0	Setup No:	5	Priority CCTV:

Source Type:	Location:	Severity:
Sector:	Drainage Area: 0	
Comments: No defects observed

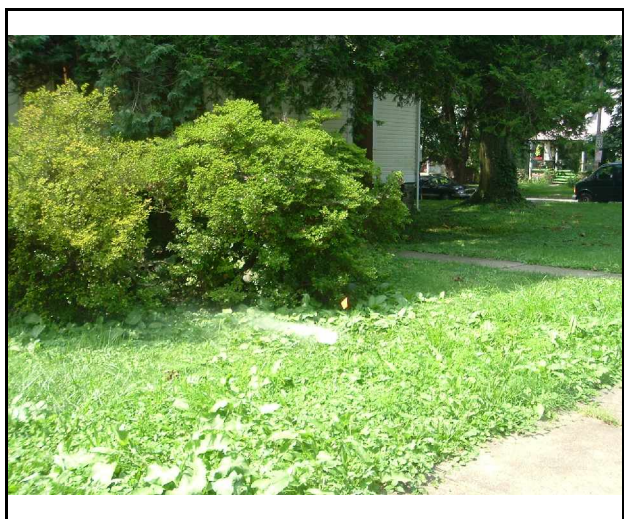
Photo No: 11

Unique Test ID	38	Date:	8/19/2004	MeterBasin:	01_WR20
Observer ID:	A	Crew:	T-1	Dye Test Recommended:	N
Defect No:	1	Setup No:	6	Priority CCTV:

House Number	Street Prefix:	Street Name:	Street Type:
2901		Whitney	AVE

Source Type:	18= Other	Location:	7=Yard-Front	Severity:
Sector:	2=Private	Drainage Area:	100

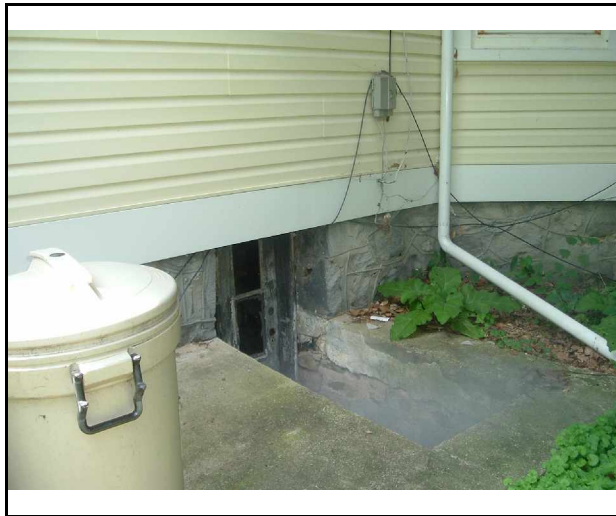
Photo No: 12

Unique Test ID	38	Date:	8/19/2004	MeterBasin:	01_WR20
Observer ID:	A	Crew:	T-1	Dye Test Recommended:	Y
Defect No:	2	Setup No:	6	Priority CCTV:

House Number	2901	Street Prefix:		Street Name:	Whitney	Street Type:	AVE
Source Type:	09= Stairwell Drain	Location:		2=Paved Asphalt	Severity:		
Sector:	2=Private	Drainage Area:		20			
Comments:

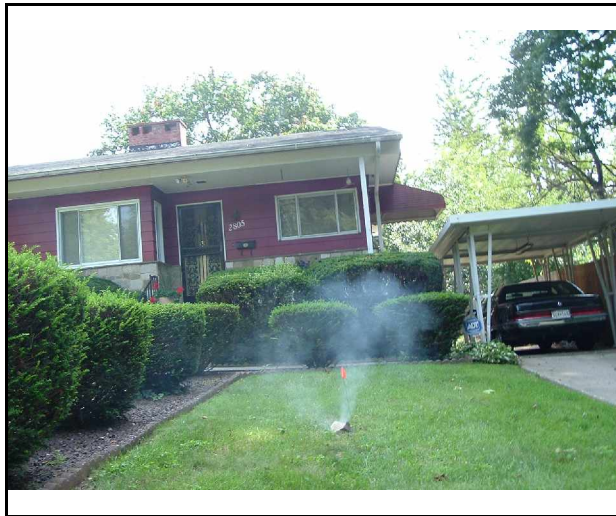
Photo No: 11

Unique Test ID	38	Date:	8/19/2004	MeterBasin:	01_WR19
Observer ID:	B	Crew:	T-1	Dye Test Recommended:	N
Defect No:	1	Setup No:	6	Priority CCTV:

House Number	Street Prefix:	Street Name:	Street Type:
2805		Whitney	AVE

Source Type:	04= Cleanout	Location:	7=Yard-Front	Severity:
Sector:	2=Private	Drainage Area:	100

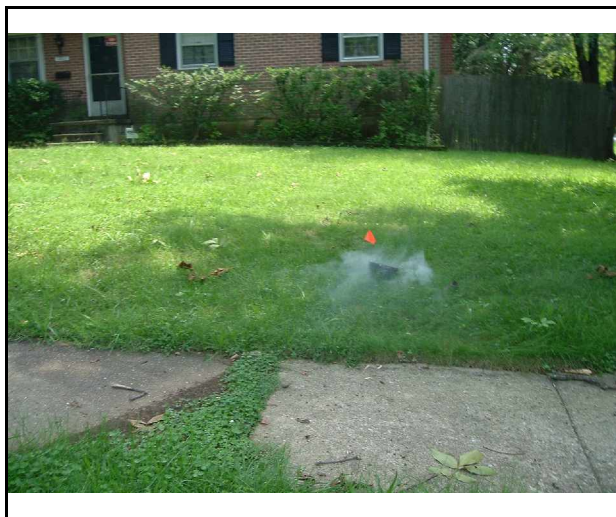
Photo No: 12

Unique Test ID	38	Date:	8/19/2004	MeterBasin:	01_WR19
Observer ID:	B	Crew:	T-1	Dye Test Recommended:	N
Defect No:	2	Setup No:	6	Priority CCTV:

House Number	Street Prefix:	Street Name:	Street Type:
2807		Whitney	AVE

Source Type:	04= Cleanout	Location:	7=Yard-Front	Severity:
Sector:	2=Private	Drainage Area:	100

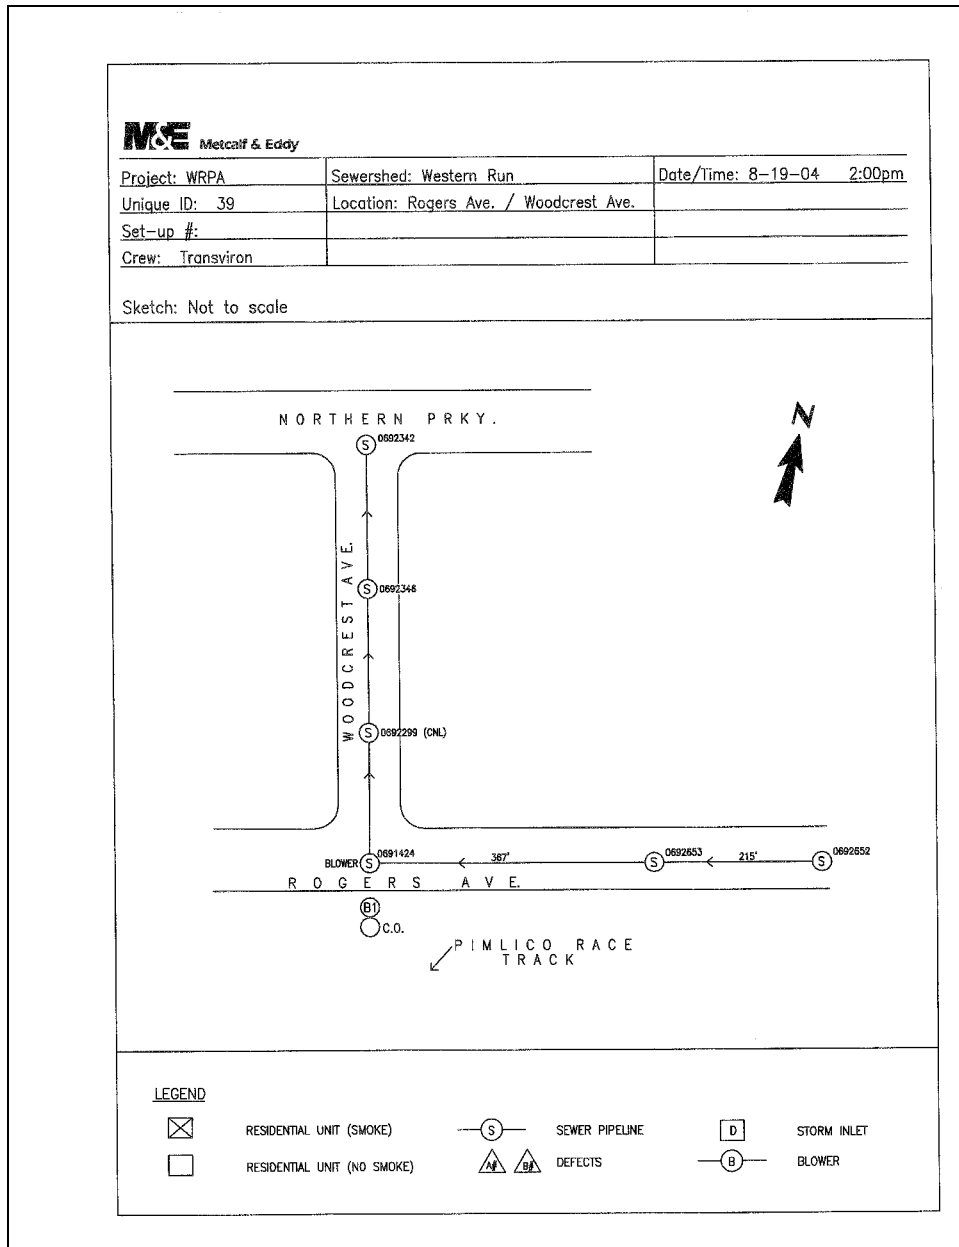
Sketch No: 39

Unique Test ID	39	Date:	8/19/2004	MeterBasin:	
Observer ID:	A	Crew:	T-1	Dye Test Recommended:	N
Defect No:	0	Setup No:	7	Priority CCTV:

Source Type:	Location:	Severity:
Sector:	Drainage Area: 0	
Comments: No defects observed

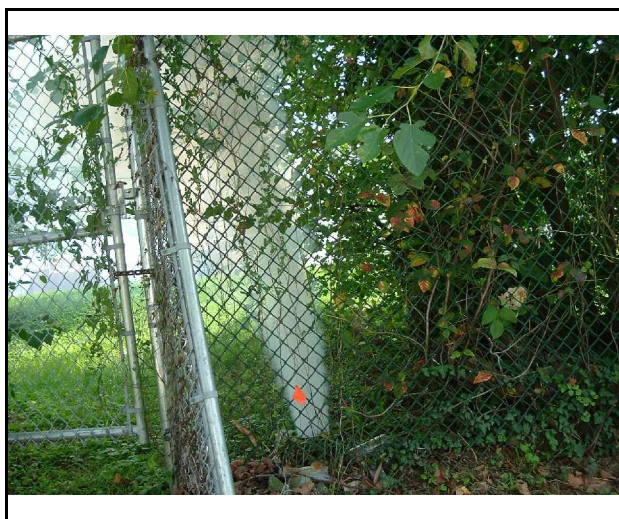
Photo No:

Unique Test ID	39	Date:	8/19/2004	MeterBasin:	01_WR20
Observer ID:	B	Crew:	T-1	Dye Test Recommended:	N
Defect No:	1	Setup No:	7	Priority CCTV:

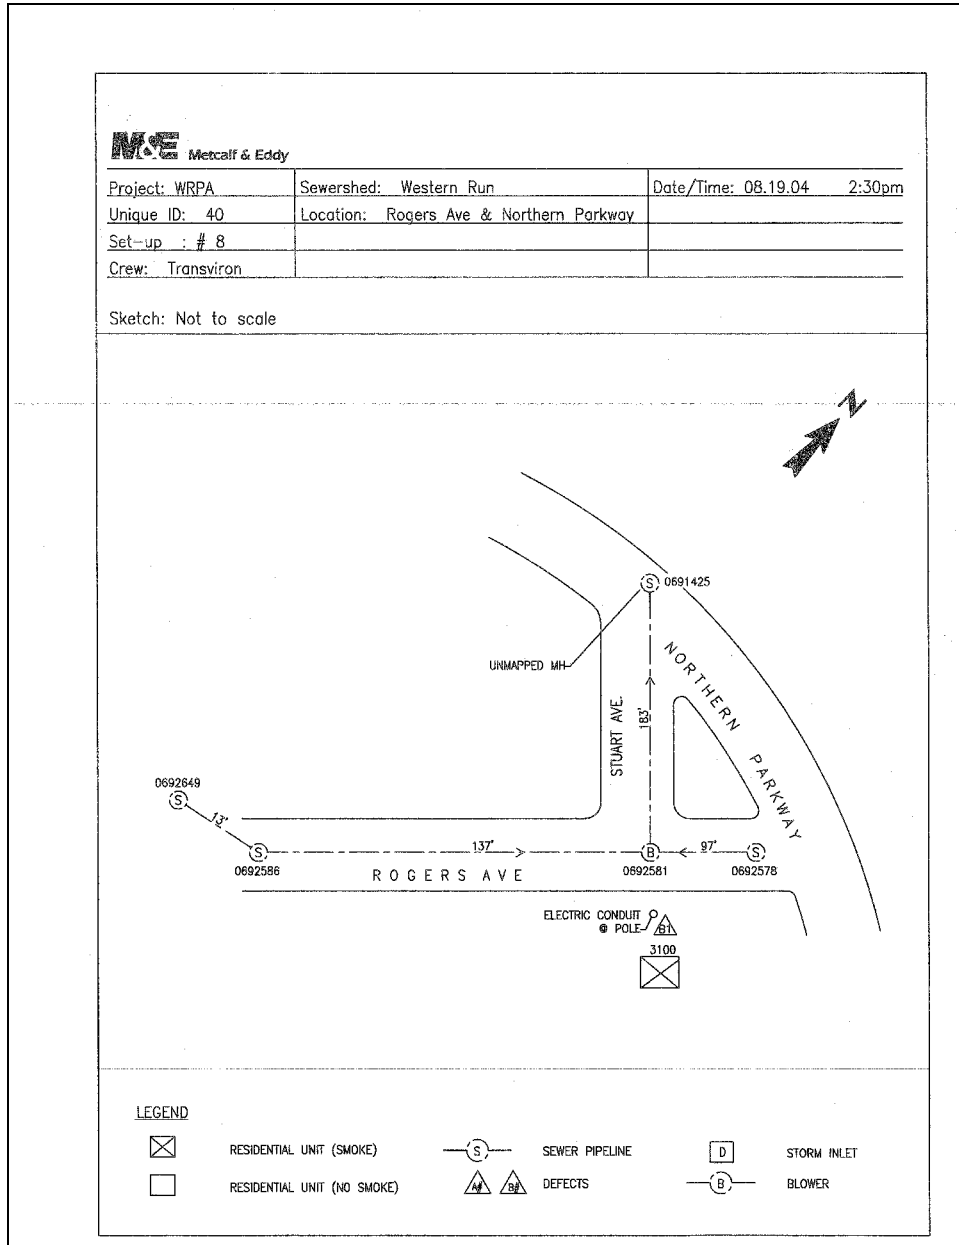
Sketch No: 40

Unique Test ID	40	Date:	8/19/2004	MeterBasin:	
Observer ID:	A	Crew:	T-1	Dye Test Recommended:	N
Defect No:	0	Setup No:	8	Priority CCTV:

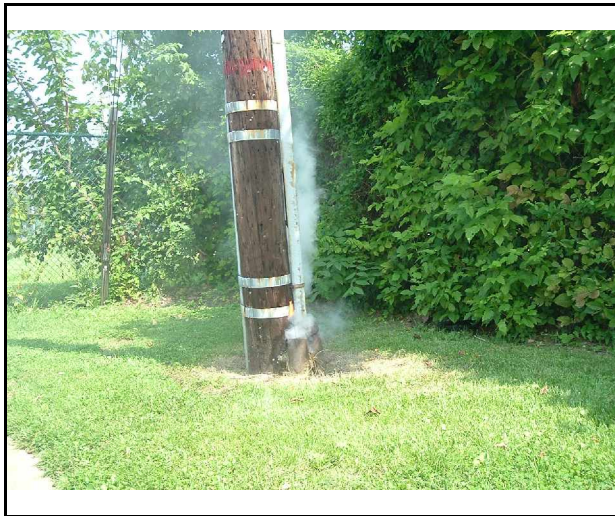
Unique Test ID	40	Date:	8/19/2004	MeterBasin:	01_WR20
Observer ID:	B	Crew:	T-1	Dye Test Recommended:	N
Defect No:	1	Setup No:	8	Priority CCTV:

Comments: Electric conduit - at utility pole - direct connection - needs futher evaluation.
